Home Inspection Report

XXXXXX, Ft. Collins, CO 80528

Monday, May 8, 2017

Cutting Edge Construction and Inspection
3321 Catamaran Ct.
Loveland, CO 80538
(970) 690-9588

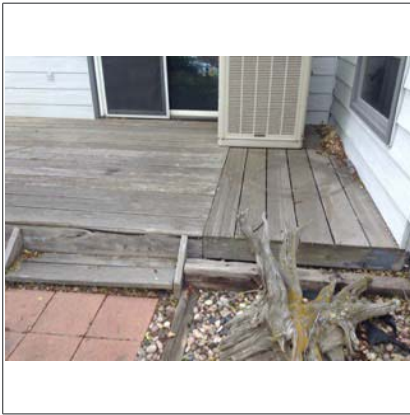
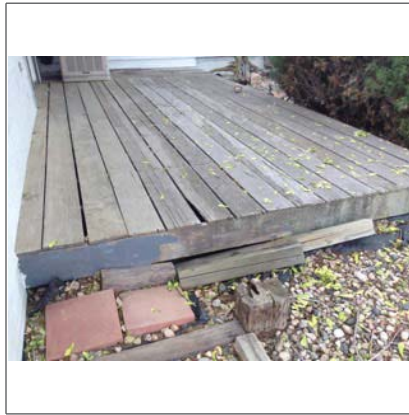
- None Not Visible
- Material** Wood Metal Composite Railing/Balusters recommended
- Condition** Satisfactory Marginal Poor Wood in contact with soil
- Finish** Treated Painted/Stained Other: bare wood Safety Hazard Improper attachment to house
- Railing loose Not Applicable
- Comments** Damaged wood on deck recommend repair and/or replacement.
Recommend painting or treating wood.

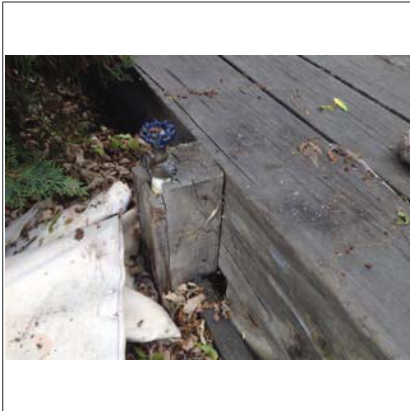
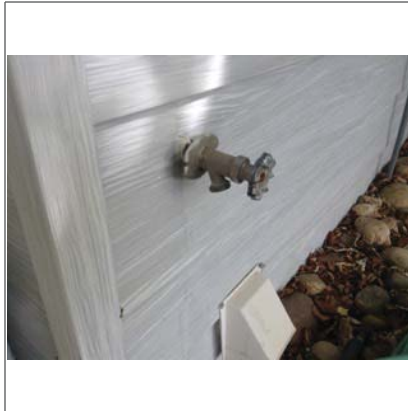
Comments Hose bib(s) not frost-proof type, recommend turning off shut off valve inside of home to prevent freezing

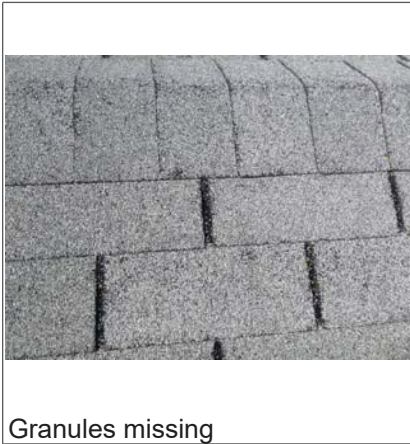
Roof appeared to be nearing end of its useful life, budget to replace soon.

Granules missing

Roof missing shingles and showing signs of age/wear, recommend roofer evaluate.

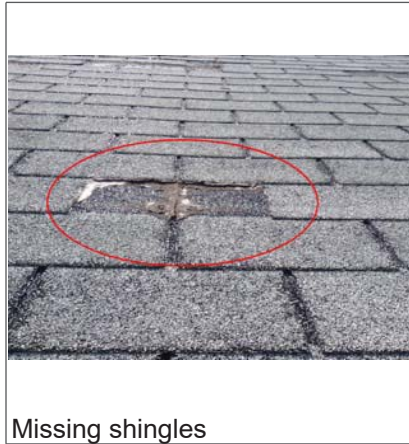
Missing shingles

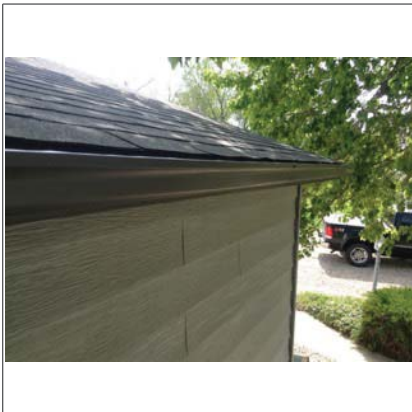
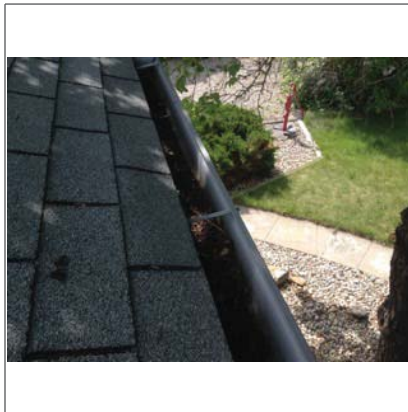
Comments Insides of gutters are full of debris recommend cleaning

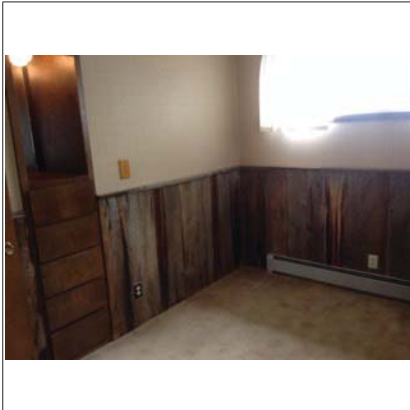
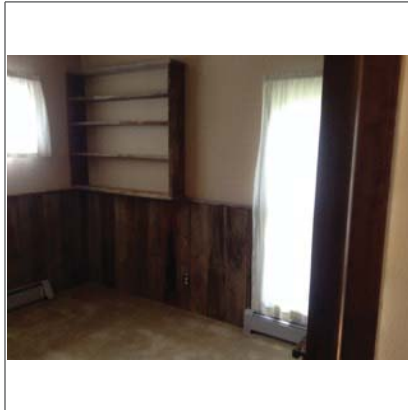
Comments Soft area in bedroom 1 sub flooring under window/baseboard heater. Potential water damage recommend flooring contractor evaluate.

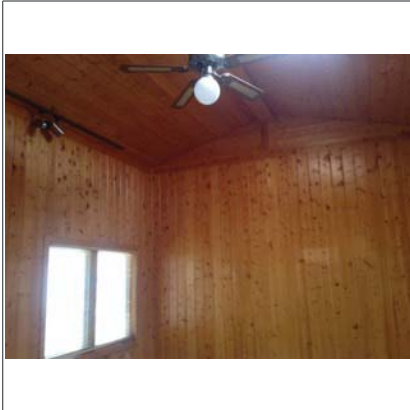
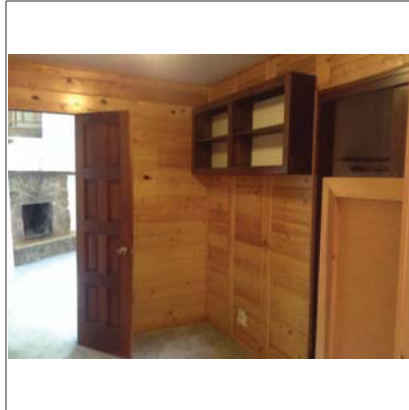
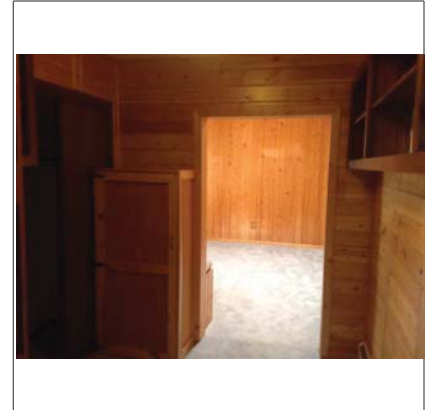
Location First floor
Type Office/bedroom addition
Walls & Ceiling Satisfactory Marginal Poor Typical cracks Damage
Moisture stains Yes No
 Where:
Floor Satisfactory Marginal Poor Squeaks Slopes Tripping hazard
Ceiling fan None Satisfactory Marginal Poor Recommend repair/replace
Electrical Switches: Yes No Operable Receptacles: Yes No Operable
 Open ground/Reverse polarity: Yes No Safety hazard Cover plates missing
Heating source present Yes No Holes: Doors Walls Ceilings
Bedroom Egress restricted N/A Yes No
Doors None Satisfactory Marginal Poor Cracked glass Broken/Missing hardware
Windows None Satisfactory Marginal Poor Cracked glass Evidence of leaking insulated glass
 Broken/Missing hardware
Comments Main floor office/bedroom ceiling fan not functioning
 Floor transition into room not flush, tripping hazard

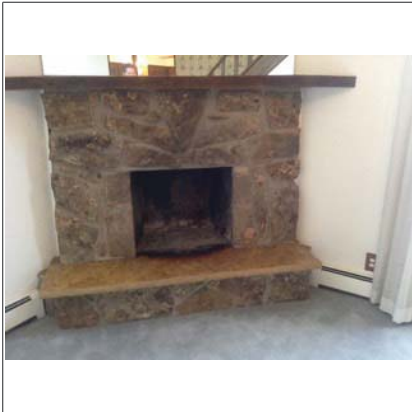
Comments Gas to family room fireplace turned off, not able to test for function at time of inspection.

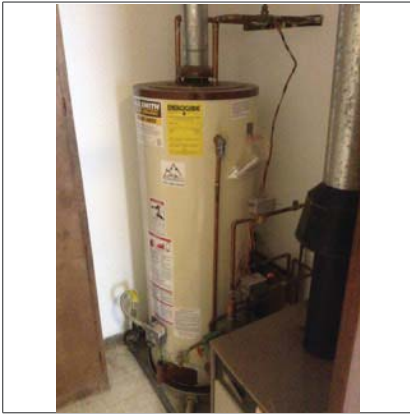
N/A
General Brand Name:
 A.O. Smith
 Serial #:
 Capacity:
 50
 Approx. age:
 20-25+
Type Gas Electric Oil LP Other: .
Combustion air venting present Yes No N/A
Seismic restraints needed Yes No N/A
Relief valve Yes No Extension proper: Yes No Missing Recommend repair Improper material
Vent pipe N/A Satisfactory Pitch proper Improper Rusted Recommend repair
Condition Satisfactory Marginal Poor
Comments Water heater manufacture date 1996 nearing the end of its useful life, plan for replacement.

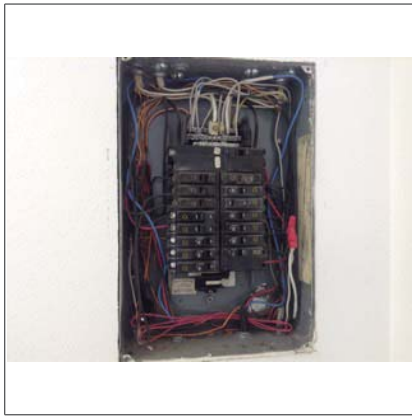
None apparent
Location(s) Location 1:
 Outbuilding
 Location 2:
 Location 3:
Evaluation Panel not accessible Not evaluated
 Reason:
 Recommend separating/isolating neutrals Recommend electrician repair/evaluate box
Branch wire Copper Aluminum Safety hazard Neutral/ground separated: Yes No
 Neutral isolated: Yes No
Condition Satisfactory Marginal Poor
Comments Some open spaces in detached garage electrical panel need covers..
