Home Inspection Report

XXXXXX, Ft. Collins, CO 80528

Monday, May 8, 2017

Cutting Edge Construction and Inspection
3321 Catamaran Ct.
Loveland, CO 80538
(970) 690-9588

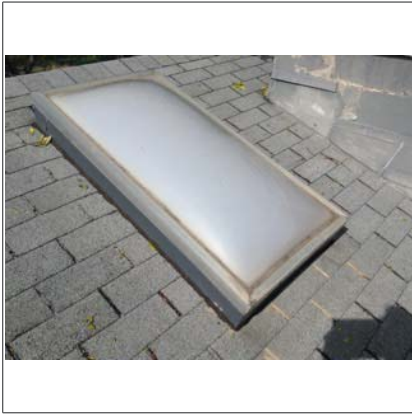
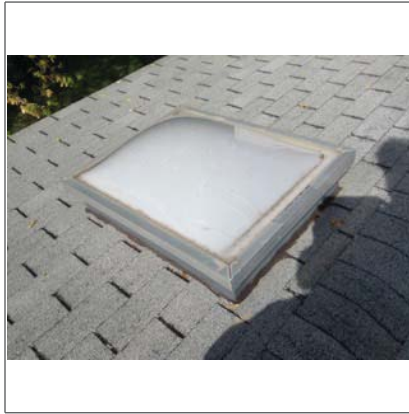
Roof appeared to be nearing end of its useful life, budget to replace soon.

Granules missing

Missing shingles

Roof missing shingles and showing signs of age/wear, recommend roofer evaluate.

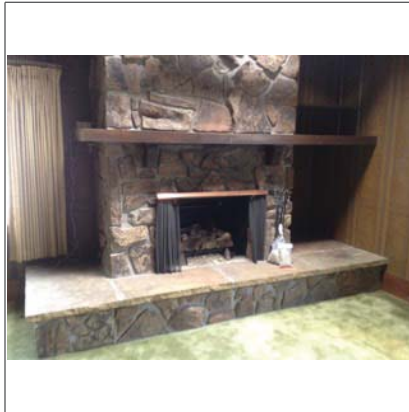
Comments Gas to family room fireplace turned off, not able to test for function at time of inspection.

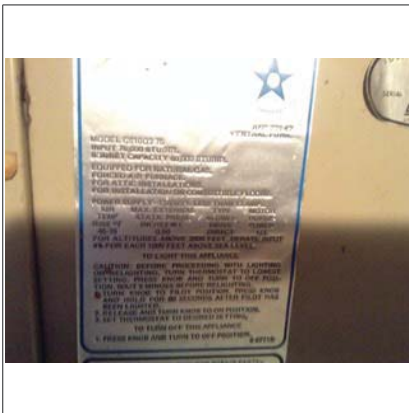
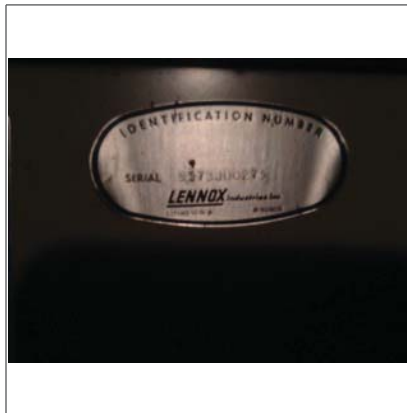
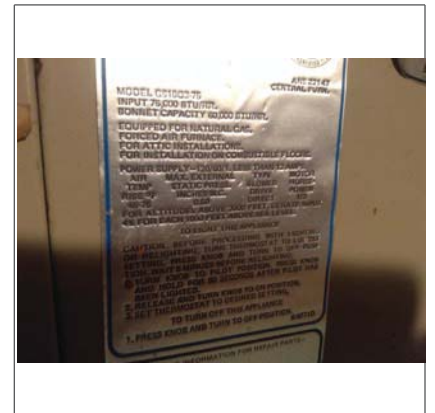
Comments Furnace was in normal working order at the time of the inspection.

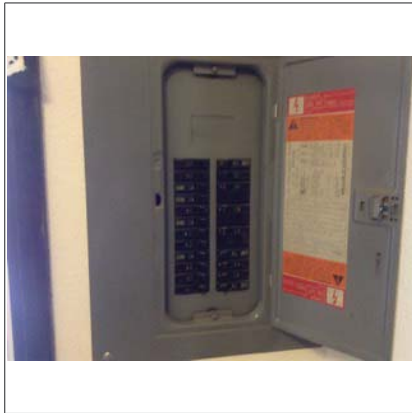
Location Laundry room
Condition Satisfactory Poor
Adequate Clearance to Panel Yes No
Amperage/Voltage Unknown 60a 100a 150a 200a 400a 120v/240v
Breakers/Fuses Breakers Fuses
Appears grounded Yes No Not Visible
GFCI breaker Yes No Operable: Yes No
AFCI breaker Yes No Operable: Yes No Not Tested
Main wire Copper Aluminum Not Visible Double tapping of the main wire
 Condition: Satisfactory Marginal Poor
Branch wire condition Satisfactory Poor Recommend electrician evaluate/repair Romex BX cable
 Conduit Knob/Tube Double tapping Wires undersized/oversized breaker/fuse
 Panel not accessible Not evaluated
 Reason:
Branch wire Copper Aluminum Solid Branch Aluminum Wiring Not Visible Safety Hazard
Comments
Photos
